Case Report

Diagnosis and Treatment of Anterior Cracked Tooth: A Case Report

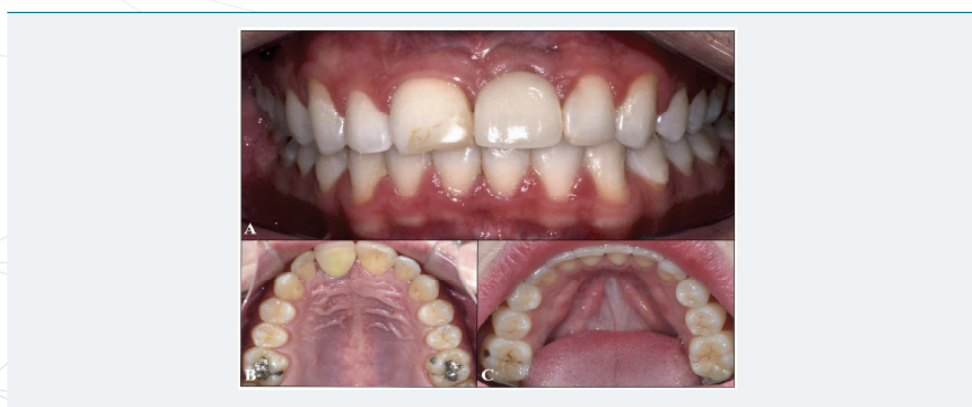
Figure 1: Examination of patient: (A) Frontal view showing a ceramic crown on the left maxillary lateral incisor (21) and a class IV composite resin restoration on the right maxillary central incisor (11) that was the chief complaint of patient; (B) amalgam restorations on the right maxillary first molar (16) (occlusal and lingual) and the left maxillary first molar (26) (occlusal and lingual); (C) amalgam restoration on the left mandibular first molar (36) (buccal).

On examination, there was a dental implant with a ceramic crown on the left maxillary lateral incisor (21) and amalgam restorations on the right maxillary first molar (16) (occlusal and lingual), left maxillary first molar (26) (occlusal and lingual), and left mandibular first molar (36) (buccal). A class IV composite resin restoration involving both incisal corners present on the right maxillary central incisor (11) was the tooth with the primary complaint (Figure 1).

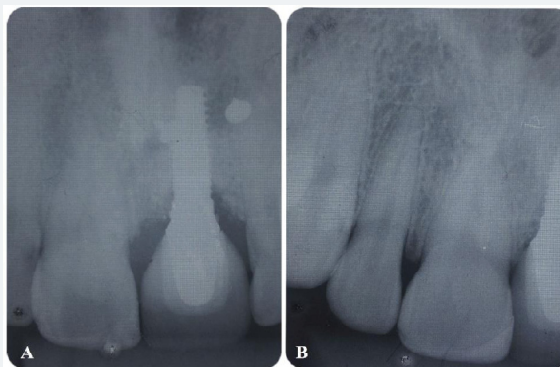
Figure 2: Radiographical examination with no signs of periapical pathologies: (A) maxillary anterior periapical radiograph and (B) maxillary anterior view with Clark's positioning.

Initially, pulp vitality tests revealed that the central incisor (11) was vital. Radiographs recorded as part of the examination included the anterior maxillary region that showed no signs of periapical pathologies (Figure 2). Subsequently, dental curing light (Radii Cal; SDI, Bayswater, Victoria Australia) was used as a transilluminator, being placed on the lingual surface of 11 to evaluate the presence of cracks; this allowed visualization of horizontal cracks in the tooth (Figure 3). Hard and soft tissue examination revealed no underlying hard or soft tissue pathologies.

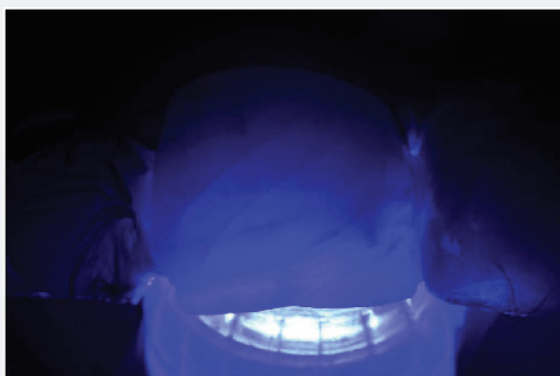
Figure 3: Transillumination with the dental curing light unit (Radii Cal; SDI, Bayswater, Victoria Australia) placed on the lingual surface of right maxillary central incisor (11), which allowed visualization of horizontal cracks in the tooth.

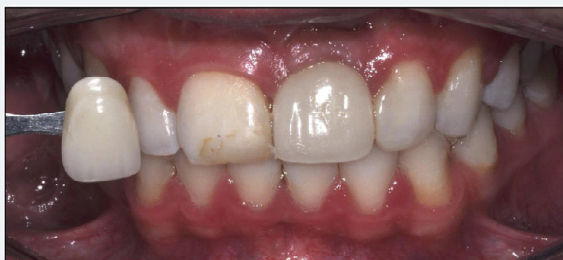
Figure 4: Color of the composite resin selected with the help of the Vita scale (VITA Zahnfabrik, Sackingen, Germany).

For repair treatment, the composite resin shade was accurately selected with the help of a Vita scale (VITA Zahnfabrik, Sackingen, Germany) (Figure 4) and through direct color selection with the insertion and light curing of small increments of resin on the tooth enamel. Since the adjacent incisor was a ceramic crown that did not present a translucent incisal edge, the selected color type for the nanofilled composite Filtek Z350 (3M ESPE, St. Paul, MN, USA) was B2 for body and B2 for enamel (3M ESPE, St. Paul, MN, USA). The color maps planned to be used are represented in figure 5. After removal of the buccal portion of previous restoration with a diamond bur (1014, KG Sorensen, Cotia, Brazil), the surface of the remaining composite was left slightly roughened with a diamond bur to facilitate adhesion. Subsequently, a 2-mm bevel was placed in a cavosurface margin by using a flame-shaped diamond bur (Figure 6).

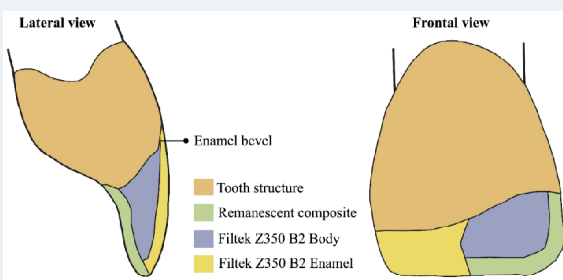
Figure 5: Color maps show layers of composite resin planned to be used in the restoration. The frontal view shows a cutaway portion and the surface layer.

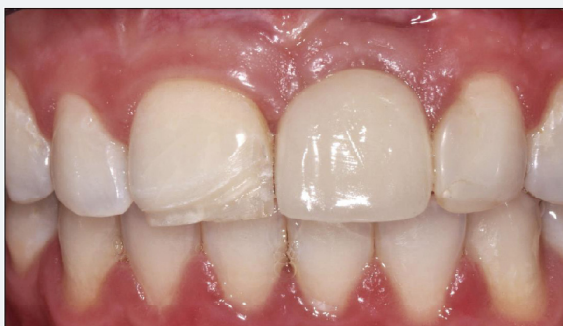
Figure 6: Tooth after removal of the buccal portion of previous restoration with a diamond bur and a 2-mm bevel placed in the cavosurface margin with a flame-shaped diamond bur.

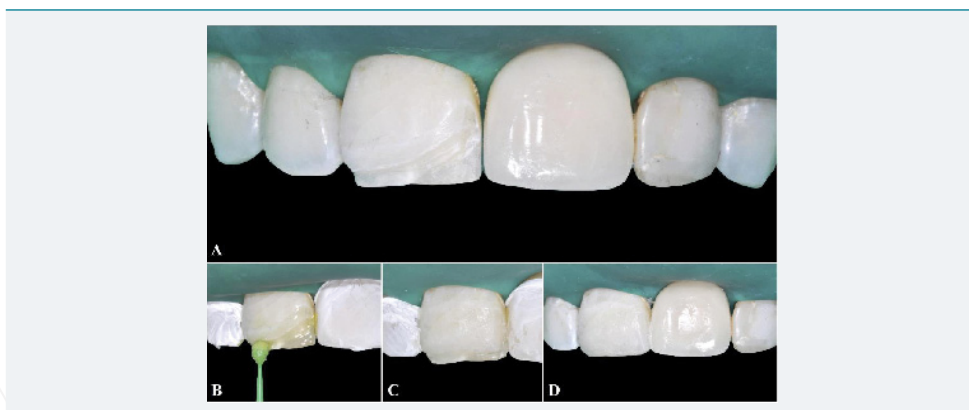
Figure 7: Repair procedure: (A) isolation performed with a rubber dam (Angelus, Londrina, PR, Brazil) to prevent substrate contamination of maxillary anterior teeth (13, 12, 11, 21, 22, and 23); (B) the universal adhesive system Scotchbond Universal (3M ESPE, St. Paul, MN, USA) was applied and light cured (Radii Cal; SDI, Bayswater, Victoria Australia); (C) Filtek Z350 of color type B2 (for body) applied above the old restoration and light cured; (D) Filtek Z350 of color type B2 (for enamel) applied over the bevel until the incisal margin. The tooth shape was carved and the composite resin was light cured.

After color selection, isolation was achieved using a rubber dam (Angelus, Londrina, PR, Brazil) to prevent substrate contamination (Figure 7A). Adjacent teeth (21 and 12) were protected, and the universal adhesive system Scotchbond Universal (3M ESPE, St. Paul, MN, USA) was applied and light cured (Radii Cal; SDI, Bayswater, Victoria Australia) according to the manufacturer’s instructions without previous acid etching (Figure 7B).

For repair, the nanofilled composite Filtek Z350 (3M ESPE, St. Paul, MN, USA) was applied using incremental and stratified techniques with 2-mm-thick increments to reconstruct lost tooth faces. Initially, Filtek Z350 of color type B2 (for body) was applied over the old existing restoration (Figure 7C), taking care to slightly overlap the fracture line with the composite and to not extend this composite until the incisal margin. The composite increments were light cured (Radii Cal; SDI, Bayswater, Victoria Australia). Then, a thin layer of Filtek Z350 of color type B2 (for enamel) was applied over the bevel until the incisal margin, the tooth shape was carved, and the composite was light cured (Figure 7D).

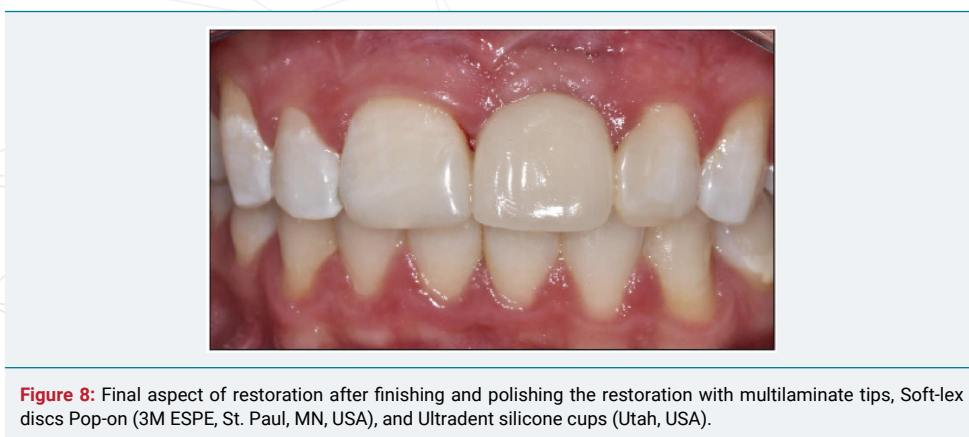
Figure 8: Final aspect of restoration after finishing and polishing the restoration with multilaminate tips, Soft-lex discs Pop-on (3M ESPE, St. Paul, MN, USA), and Ultradent silicone cups (Utah, USA).

An occlusal test was performed using carbon paper. During the same appointment, finishing and polishing of the restoration was achieved using multilaminate tips, Soft-lex discs Pop-on (3M ESPE, St. Paul, MN, USA), and Ultradent silicone cups (Utah, USA). Moreover, enamel perikymata were reproduced by drawing small transverse ridges on the tooth surface with the help of a diamond bur (2135FF, KG Sorensen, Cotia, Brazil). Subsequently, the restorations were polished using a felt disc and diamond paste (Diamond Flex, FGM, Joinville, Brazil) from the direction of the composite resin toward the tooth.

The esthetic quality of the restoration was considered satisfactory by the patient. Figure 8 presents the final aspect of the restoration that was also approved (Figure 9).

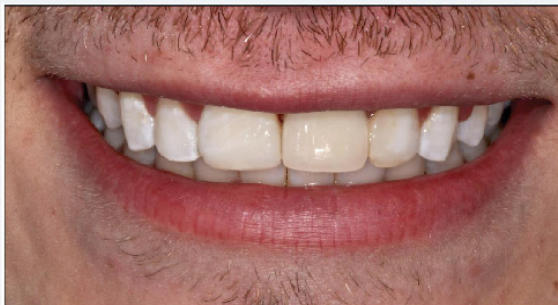
Figure 9: Patient's smile after restoration. The esthetic quality of the restoration was considered satisfactory and approved by the patient.
